LAKE LEHIGH DAM

(NDI ID ^{Number} PA-00151
DER ID ^{Number} 64-51)

PHASE I INSPECTION REPORT.
NATIONAL DAM INSPECTION PROGRAM

GANNETT FLEMING CORDDRY AND CARPENTER, INC.
Consulting Engineers
P.O. Box 1963
Harrisburg, Pennsylvania 17105

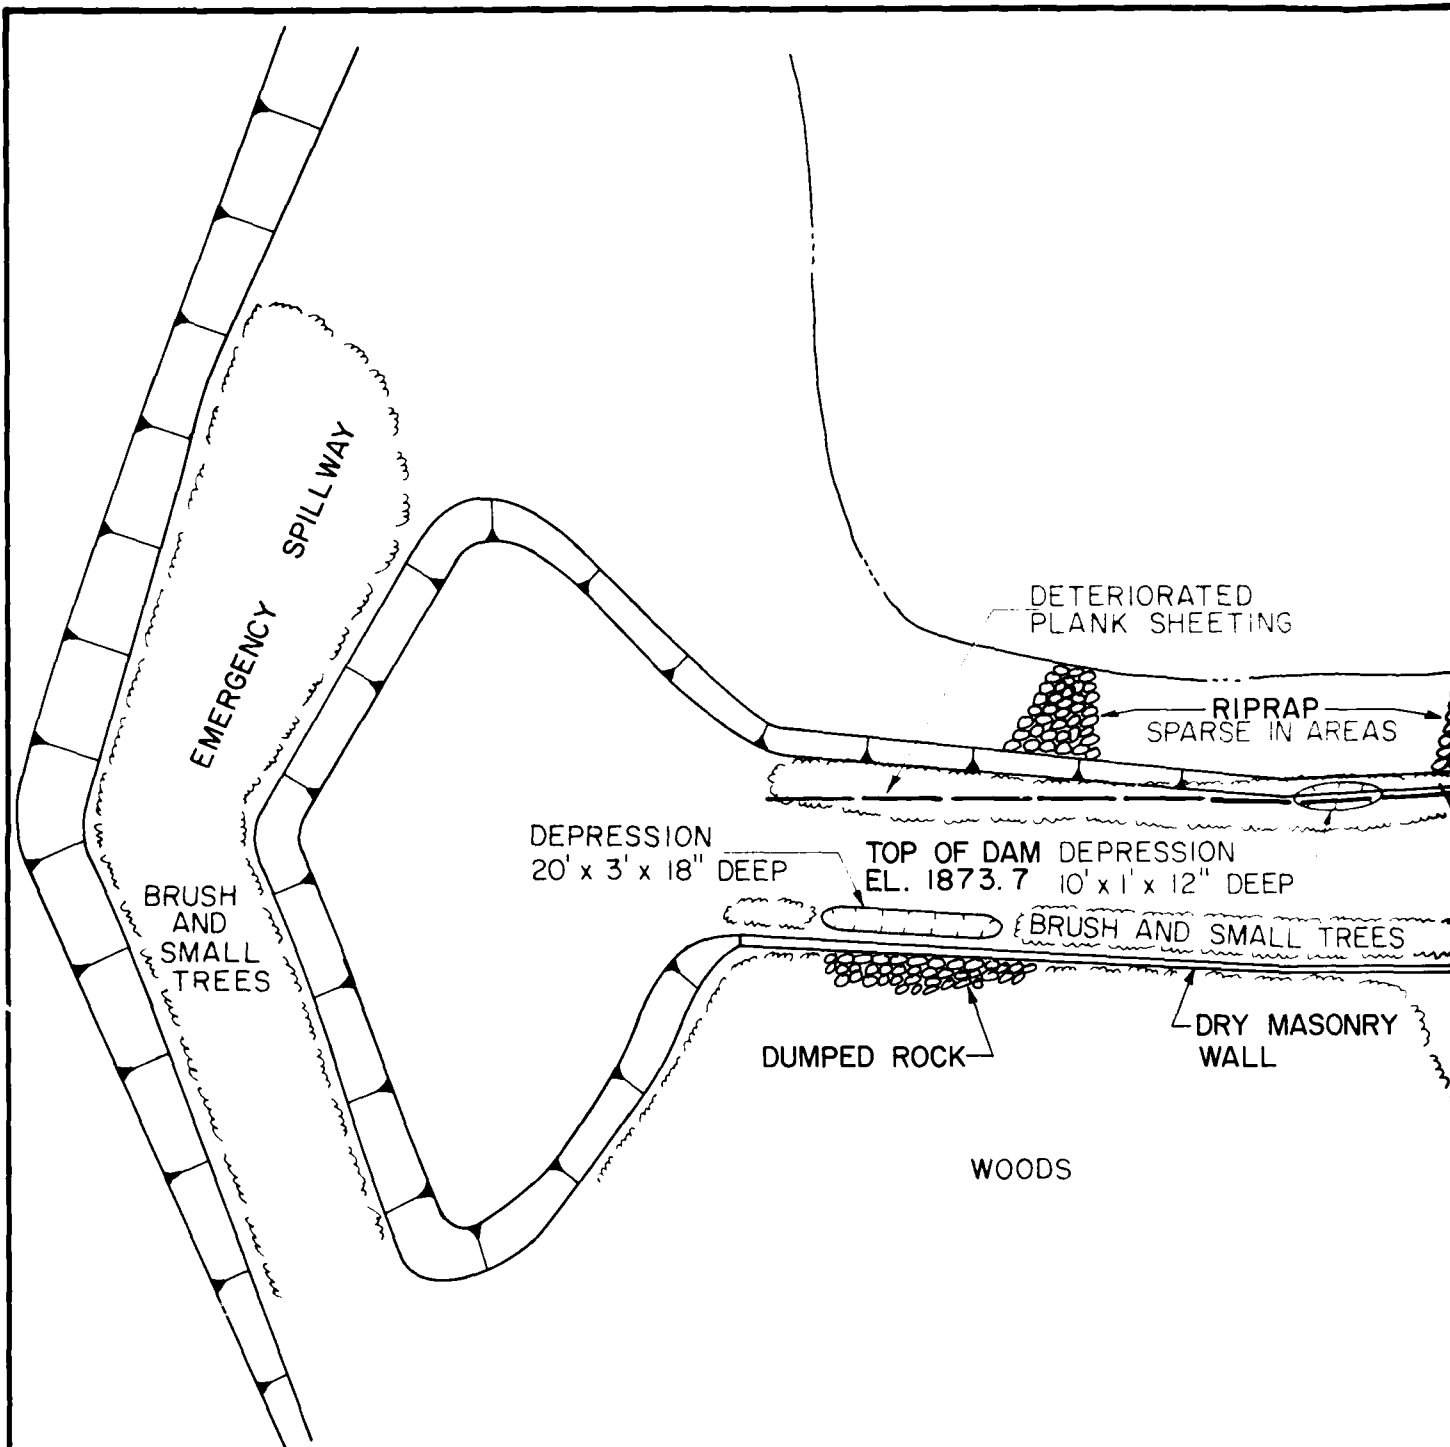
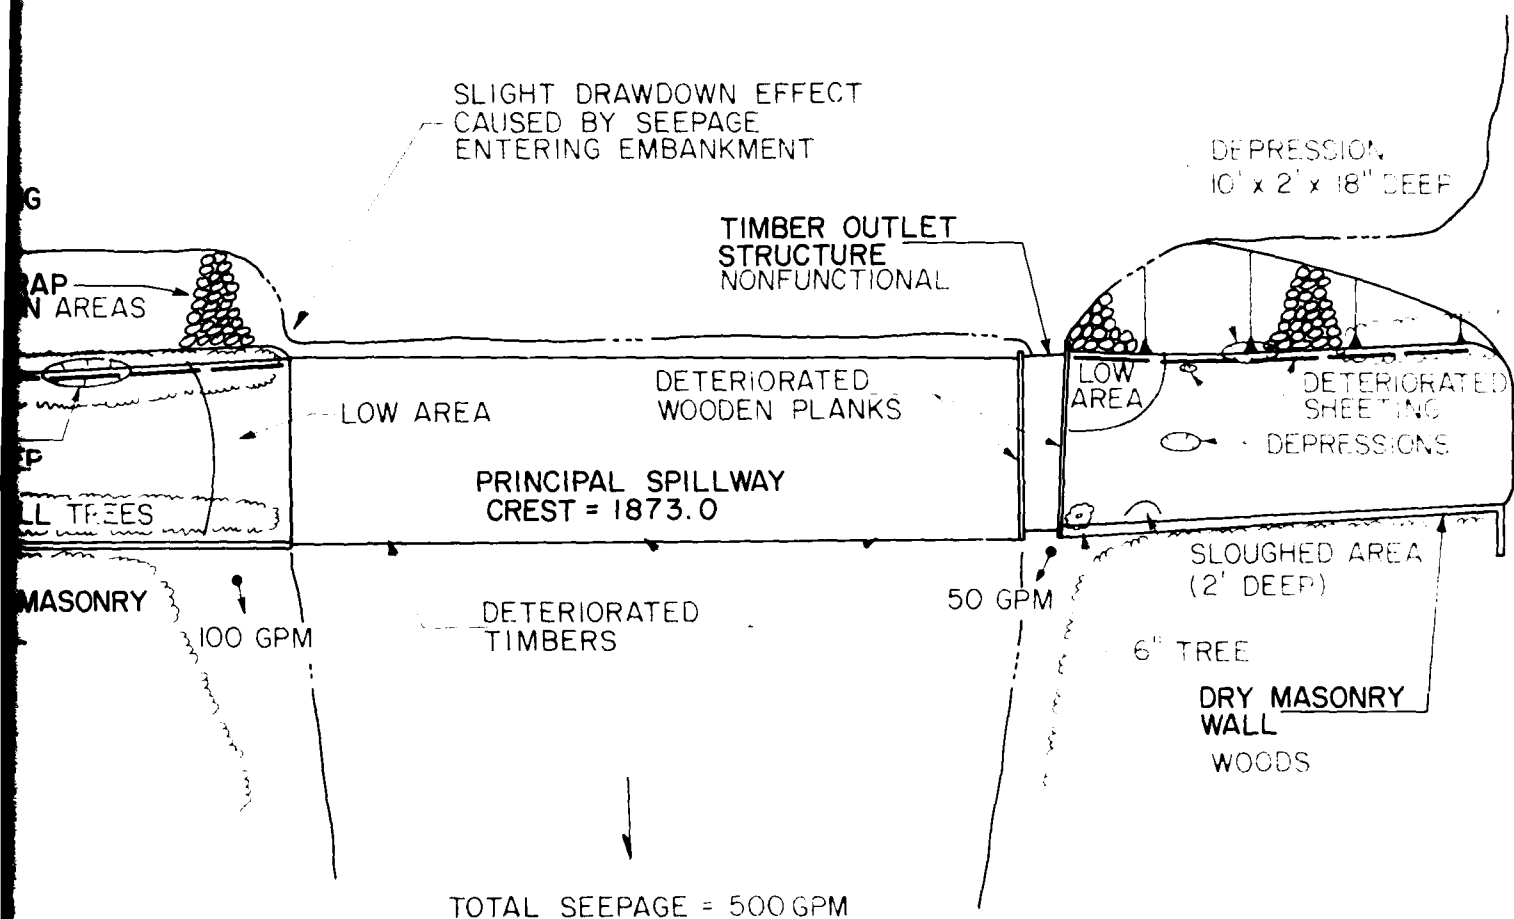
EXHIBIT B-1

| VISUAL EXAMINATION OF | OBSERVATIONS | REMARKS OR RECOMMENDATIONS |
|---|---|---|
| SLOUGHING OR EROSION: Embankment Slopes Abutment Slopes | Low or eroded areas on both sides of principal spillway; sloughed area on downstream edge of dam crest to left of spillway. | See Exhibit B-1 Low areas may be caused by internal erosion or previous overtopping. |

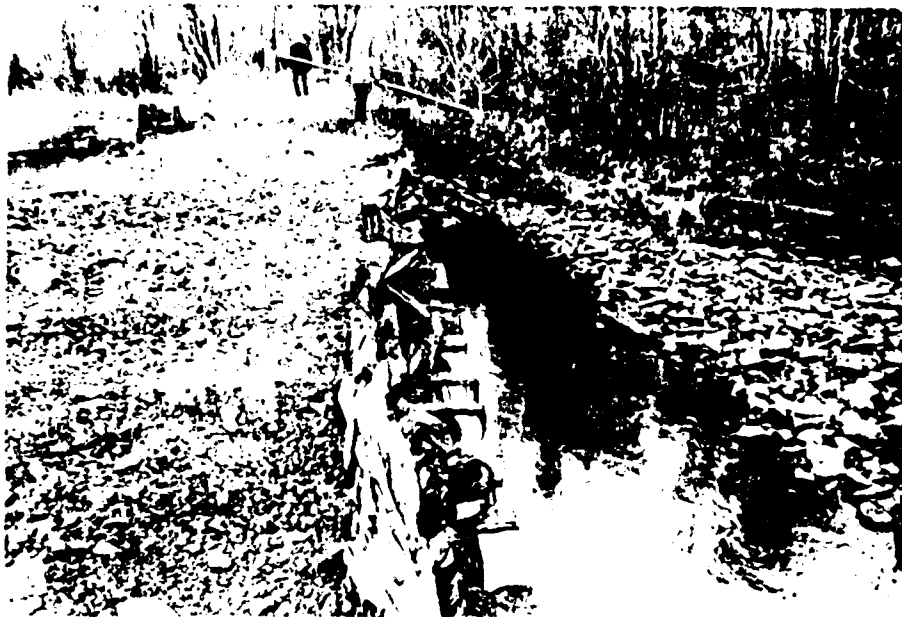
c. Principal Spillway. The timbers forming the spillway are very badly deteriorated. This is probably the result of continuous wetting and drying during the 80-year life of the structure. The crest of the spillway has been altered substantially from its original configuration. This alteration was probably performed in an attempt to delay deterioration of the structure. The crest is now surfaced with stone and small rock and is contained on the downstream edge by wooden planks and corrugated sheet metal. The vertical wooden planks at each end of the spillway are also badly deteriorated which tends to create voids within the dam. Although the downstream toe of the structure was submerged, it is estimated that a substantial percentage of the total seepage from the dam is flowing under or through the spillway. Overall the spillway is in very poor condition.

(3) Appurtenant Structures. The deteriorated timbers of the principal spillway create significant concern as to the stability of the structure. It is estimated that the existing spillway would not be able to resist scouring caused by ice or large overflows from the reservoir.

C. Crest of principal spillway looking toward left abutment.

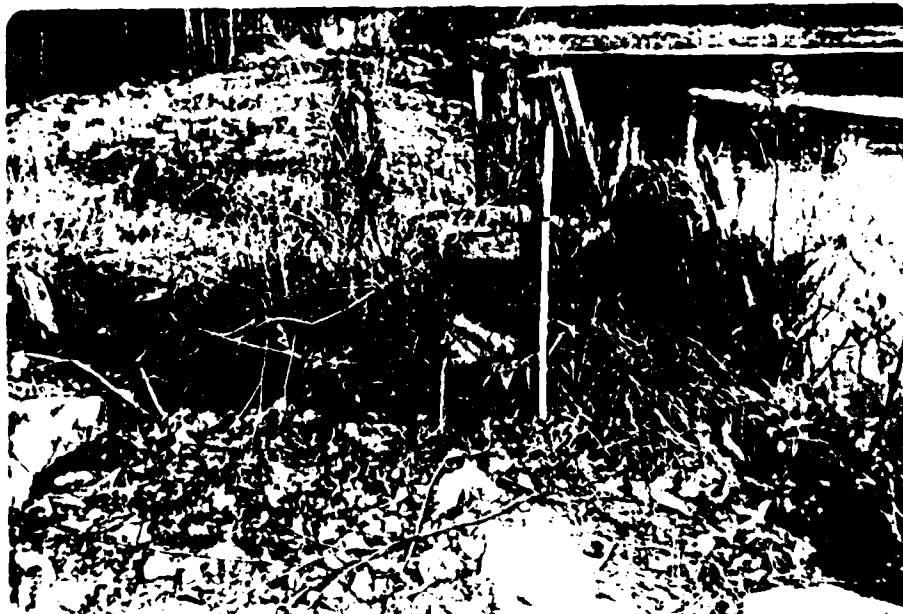
b. Embankment. The crest, upstream slope, and downstream toe of the dam are partially overgrown with brush and small trees ranging in size up to six inches in diameter. Low areas were observed on the crest of the dam adjacent to and at both ends of the principal spillway. Each low area is approximately 80 to 100 square feet in size and 12 to 18 inches lower than the remainder of the embankment. Concentrated seepage was observed at the toe of the dam at both locations. A slight drawdown of the water surface was observed at the upstream side of the dam to the right of the spillway where the seepage entered the embankment. The flow could be heard rushing through the embankment at both ends of the spillway. It is possible that this seepage is causing internal erosion of the dam which could be responsible for the low areas. The low areas may also have been caused by overtopping of the dam during high pool levels. The total seepage from the dam was estimated at 500 gallons per minute (gpm). A significant portion of this is probably flowing through or under the principal spillway. The toe of the spillway could not be observed as it was submerged.

The depressions observed on the crest of the dam are also signs of embankment instability. Although the exact cause of these depressions is unknown, it is believed that they are caused by migration of soil particles near the top of the embankment into voids within the embankment. The growth of trees and brush on the dam is undesirable. Root systems can loosen embankment material and eventually create paths along which seepage and piping (internal erosion) might occur. The small sloughed area adjacent to the wooden flume, although not considered serious at this time, can develop into a problem if allowed to go unchecked.

D. Low area at left spillway abutment.

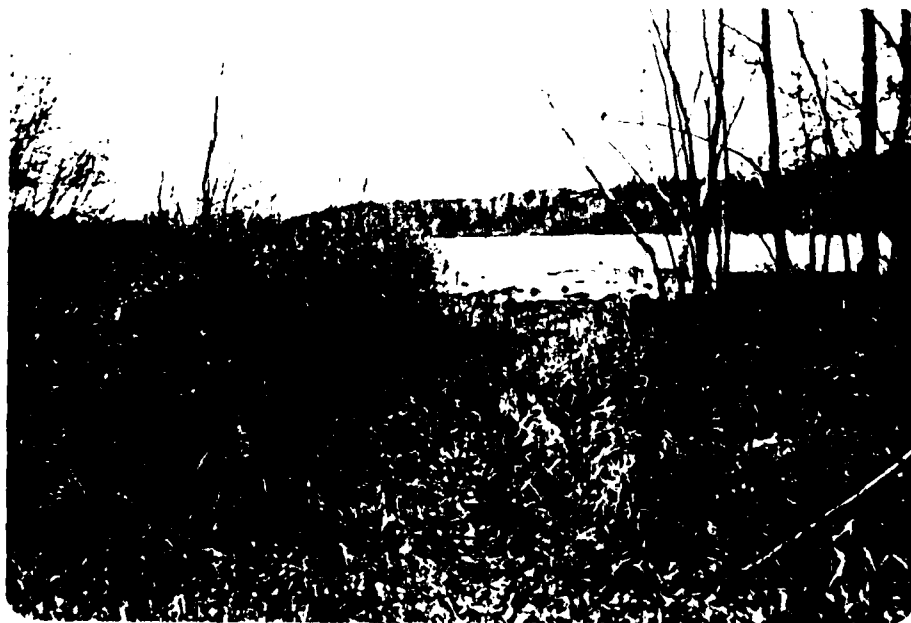
H. Emergency spillway approach channel.
